Report from Strasburg Observations

On Friday, November 14, 2008 I met with Rick Musser at the Strasburg Railroad Company to inspect work progressing on the firebox of Engine 39. I am pleased to report that much has occurred on the firebox since my visit three months ago on August 19.

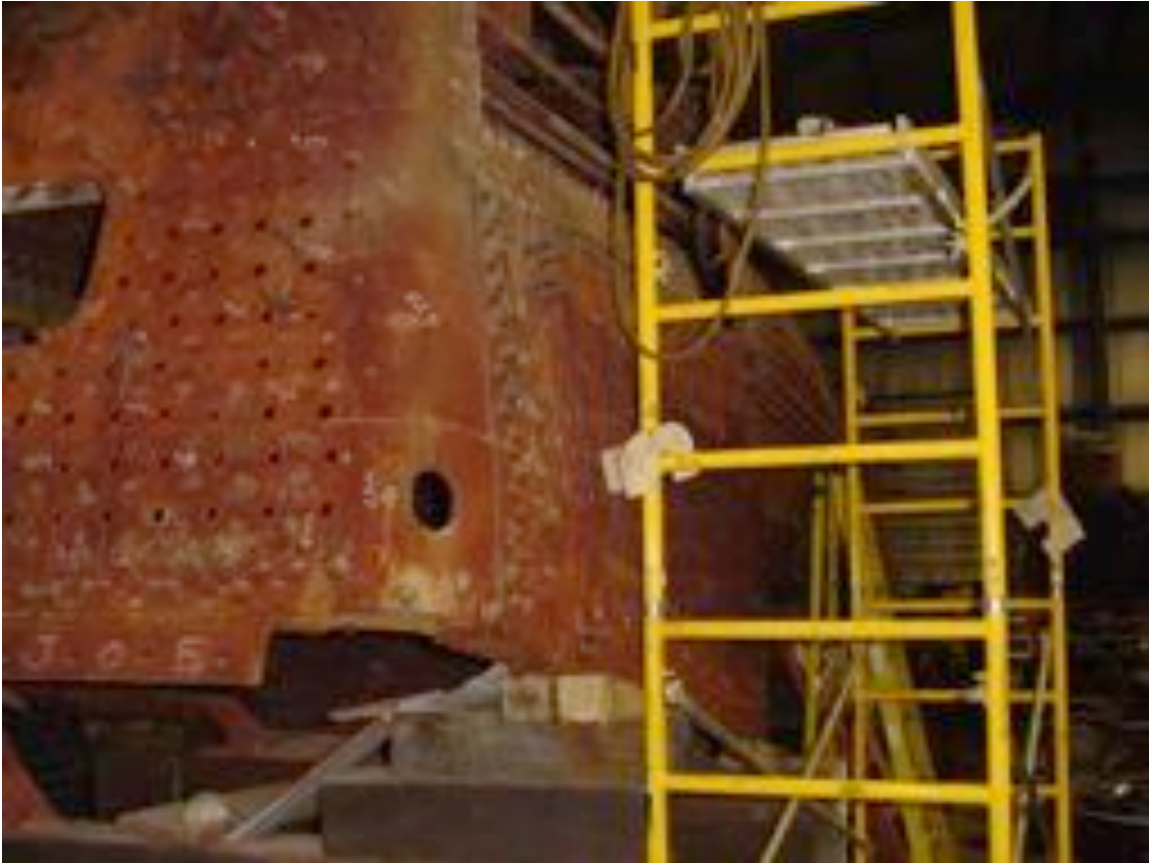
From this photo we see that the roof sheet and upper side sheets have been cut away and removed from the Belpaire firebox. The roof sheet was removed because it is too thin for the “bolt pitch,” the number of and distance between staybolts supporting the sheet. The roof sheet will be replaced with thicker steel to make up for the bolt spacing, “pitch.” Additionally, this provides for easy inspection of the support rods and the composition of the side sheets. Note the numerous bare spots and numbers on the backhead.

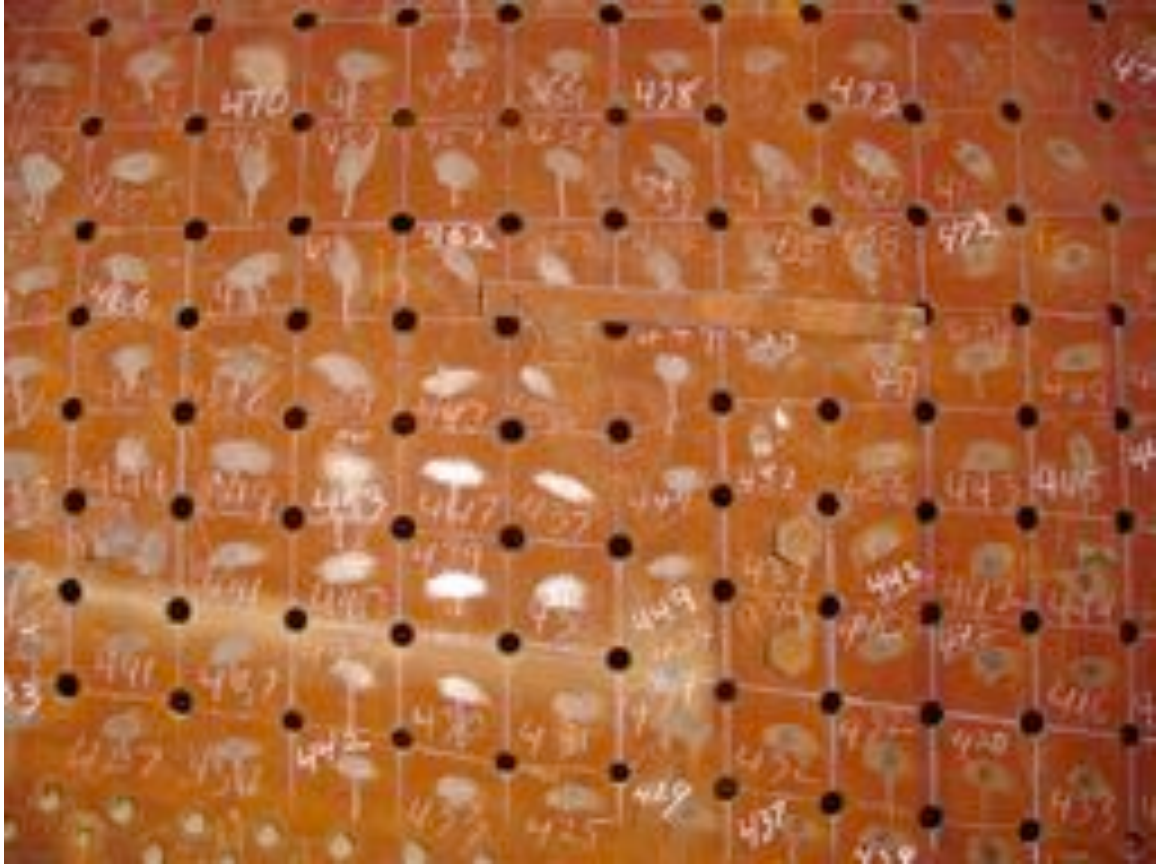
In this photo of 39's side sheets, note the polished metal evenly spaced between each staybolt hole. It is here that the UT readings are taken. The number is the thickness reading found at that location.

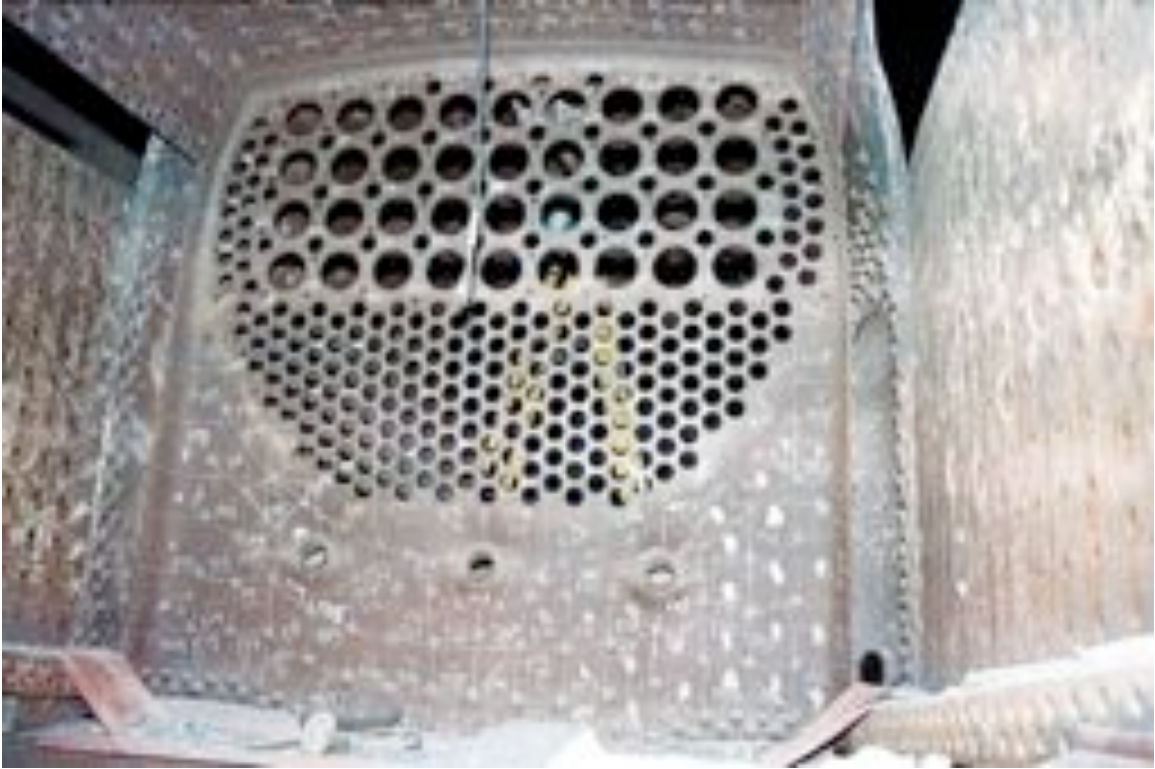
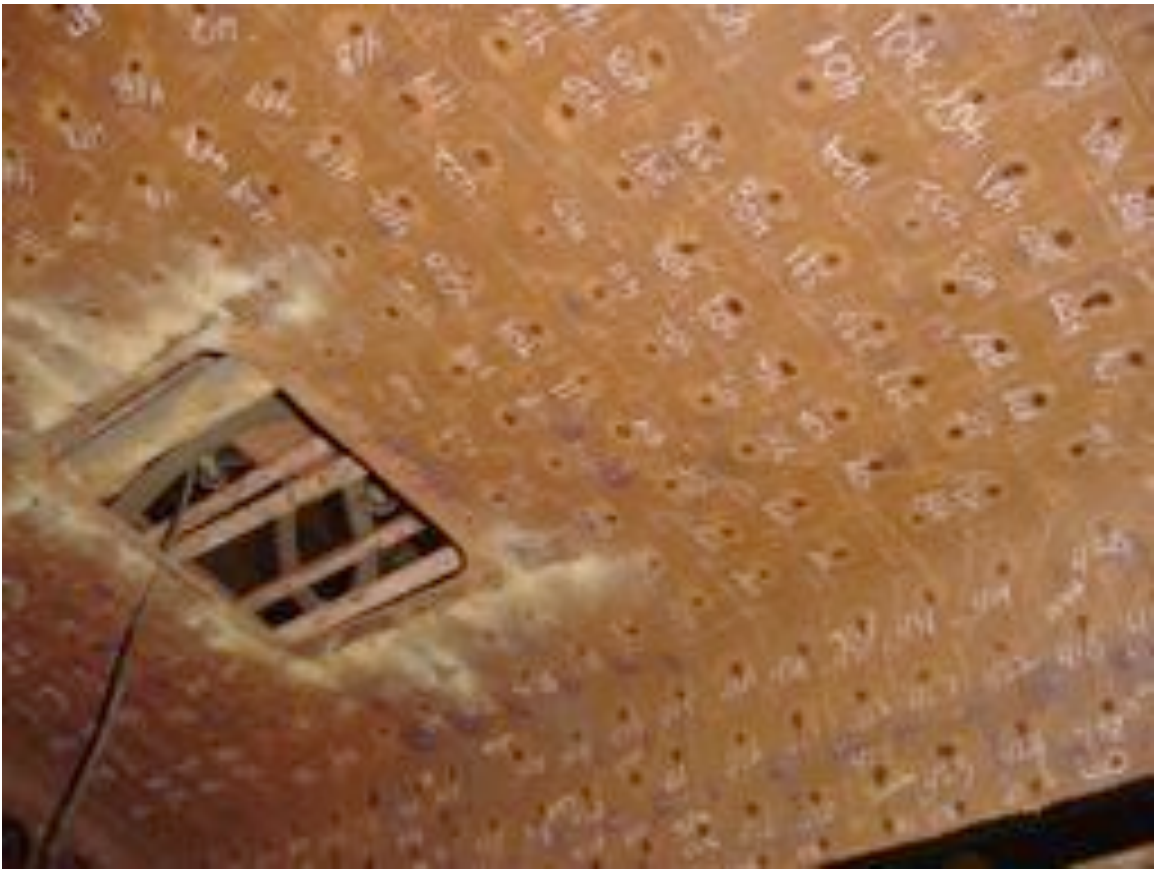
UT readings and their numerical findings cover the rear flue sheet and inside the crown sheet.

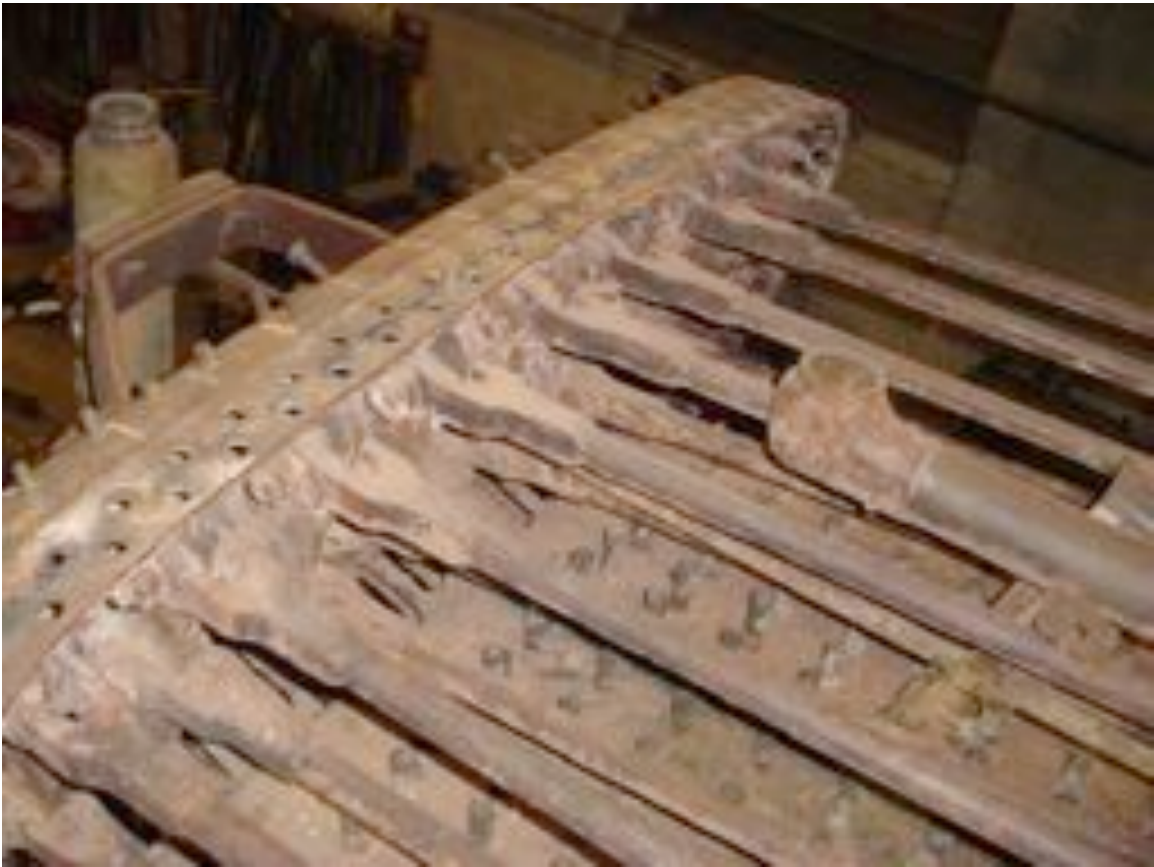
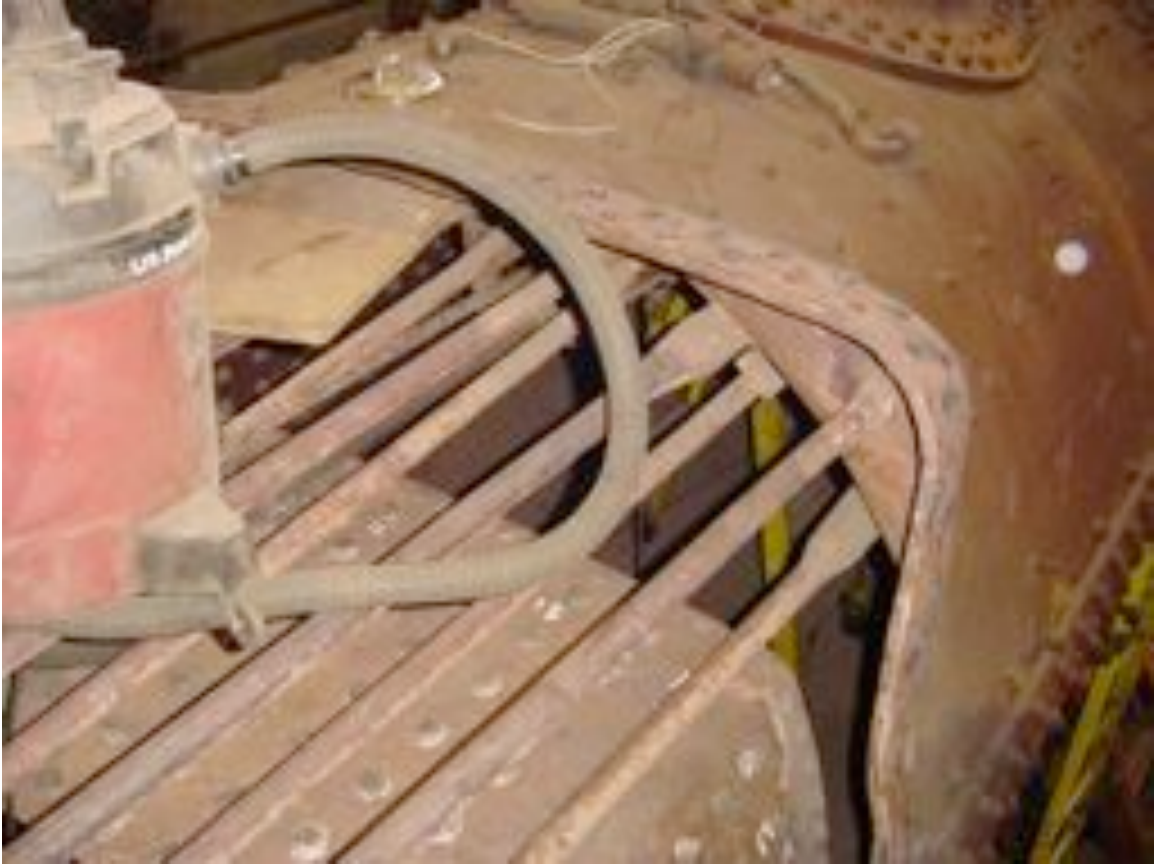
Here we see photos of the many support rods, (backhead braces), that have been uncovered by the removal of the roof sheet. These rods will be Magnaflux tested for soundness. You may recall that one of these rods had been found broken during my August visit, that rod and any other rods that do not pass testing will be manufactured and replaced by Strasburg.

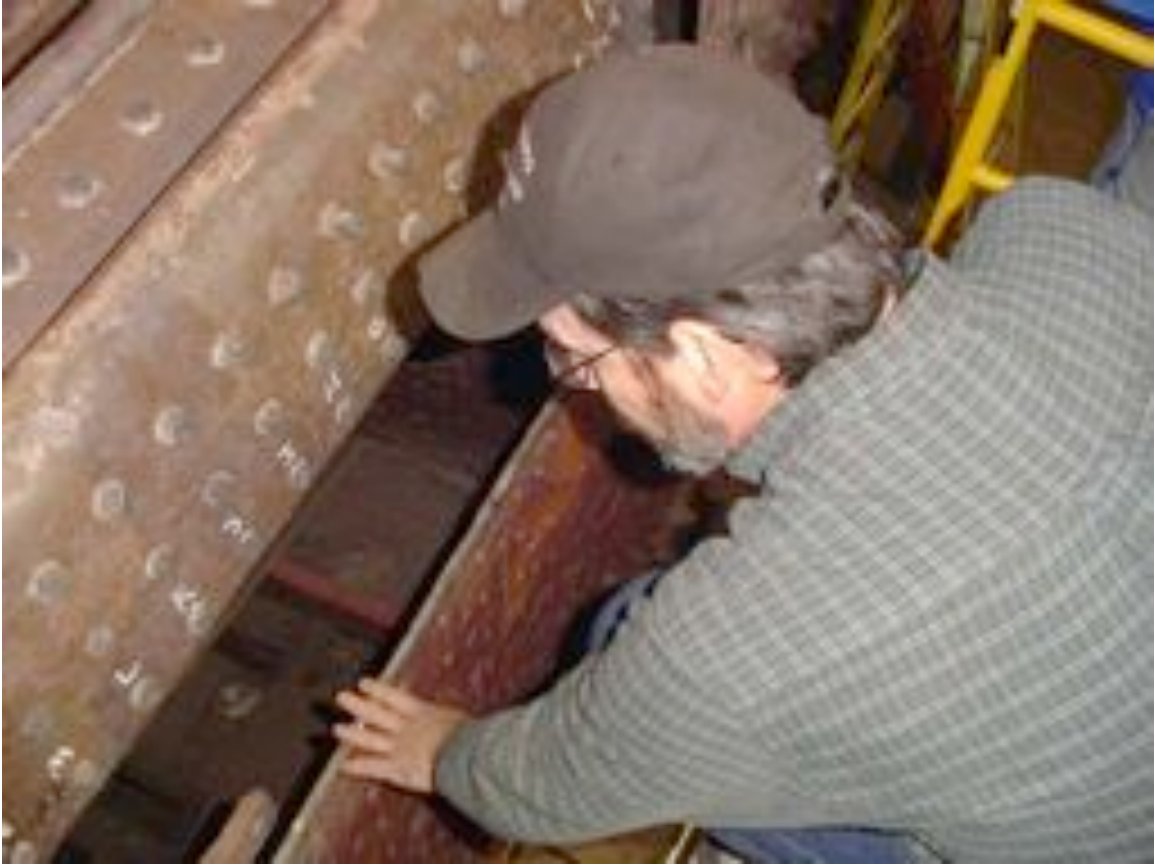
Inspection of the side sheets has uncovered quite a lot of steel impurities or laminations, (“dirty steel”).

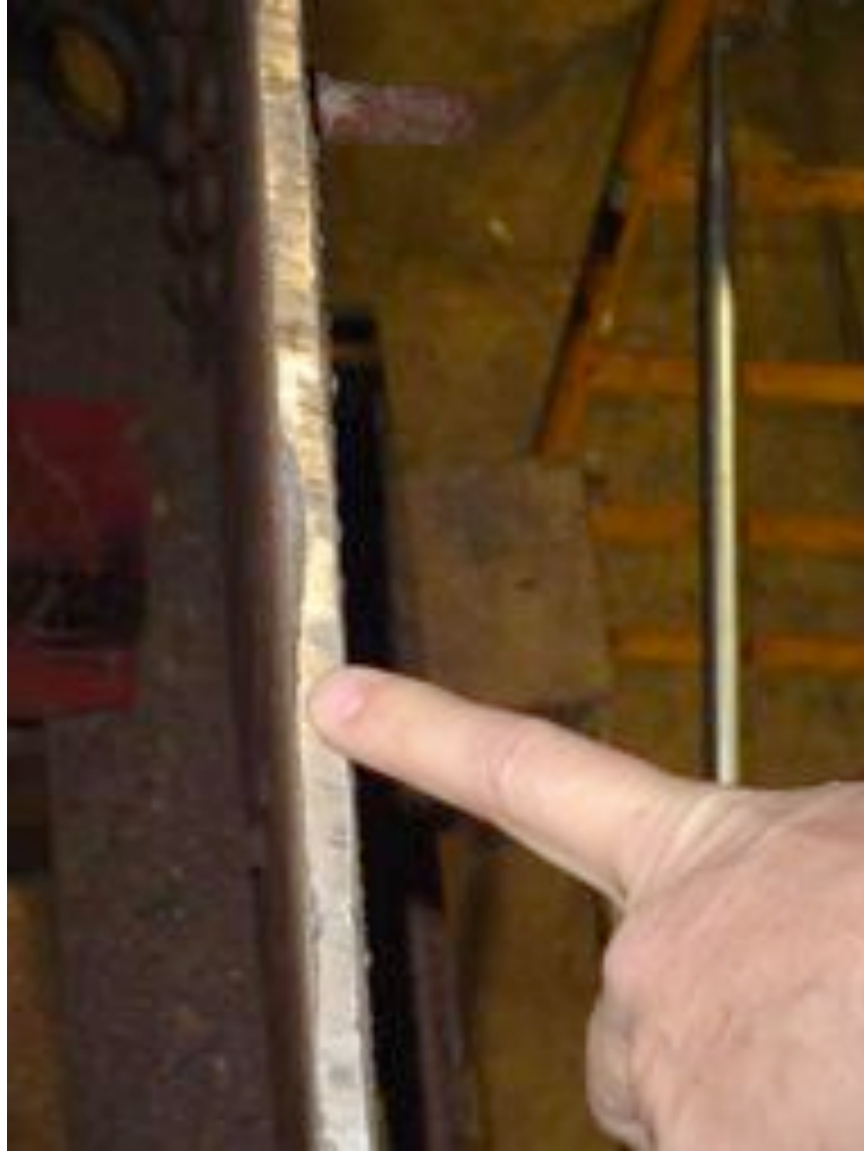
Here, Rick points to evidence of lamination in the steel plate. The laminations must be removed and repaired by welding so the material is "sound" as per the National Board Inspection Code. If the laminations and/or pitting are too extensive, the side sheet will be replaced.

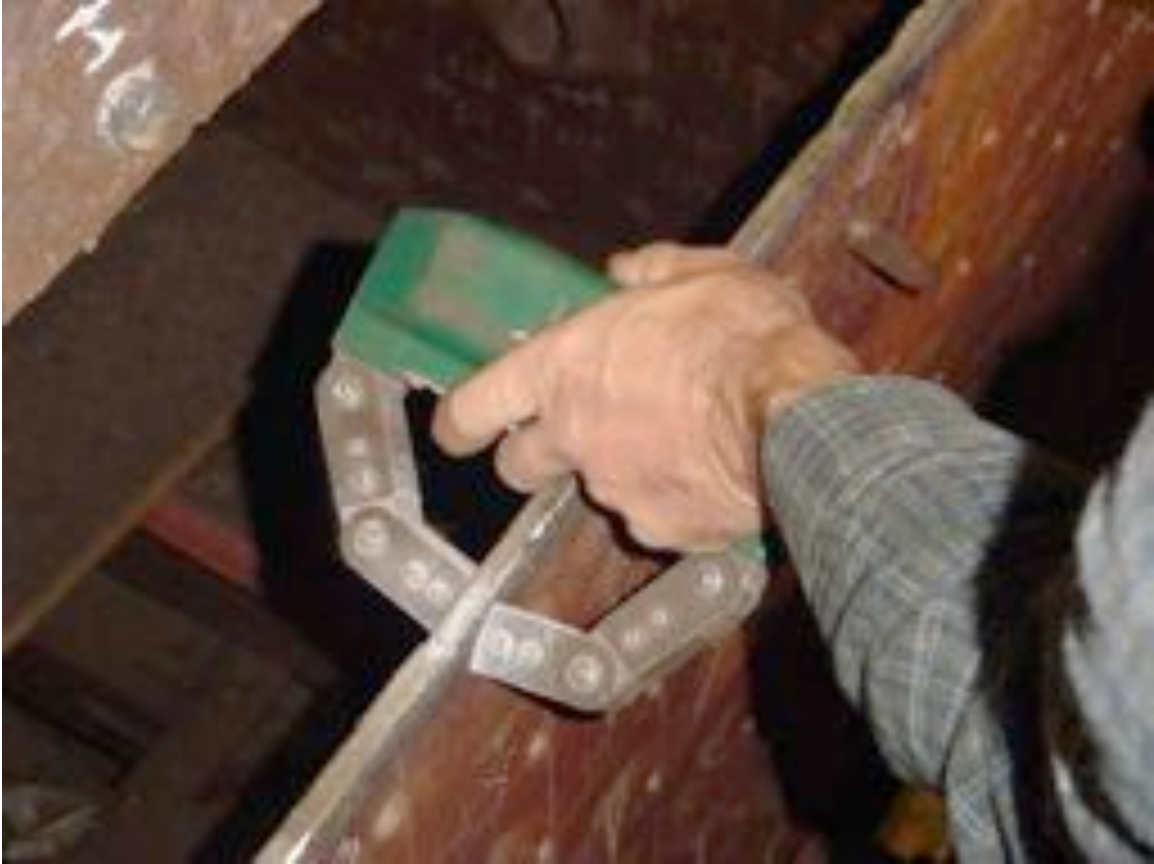
You may remember my discussion in August about the “dirty steel” being used in Pennsy locomotives of the time. Welding must be done only on material that shows no evidence of laminations. To check the steel for impurities before welding, the craftsman employs a Magnaflux machine. Seen above, the appliance sets up a tremendous magnetic field around and through the material being tested. A powder composition of iron filings is cast upon the edge of the material. Wherever there is banding, the filings collect and create a pattern that “illuminates” the lamination. Further testing is done to see how far the impurities extend into the sheet. If there is extensive deep penetration of impurities and it becomes impossible to find good steel to weld on and the old material is replaced.

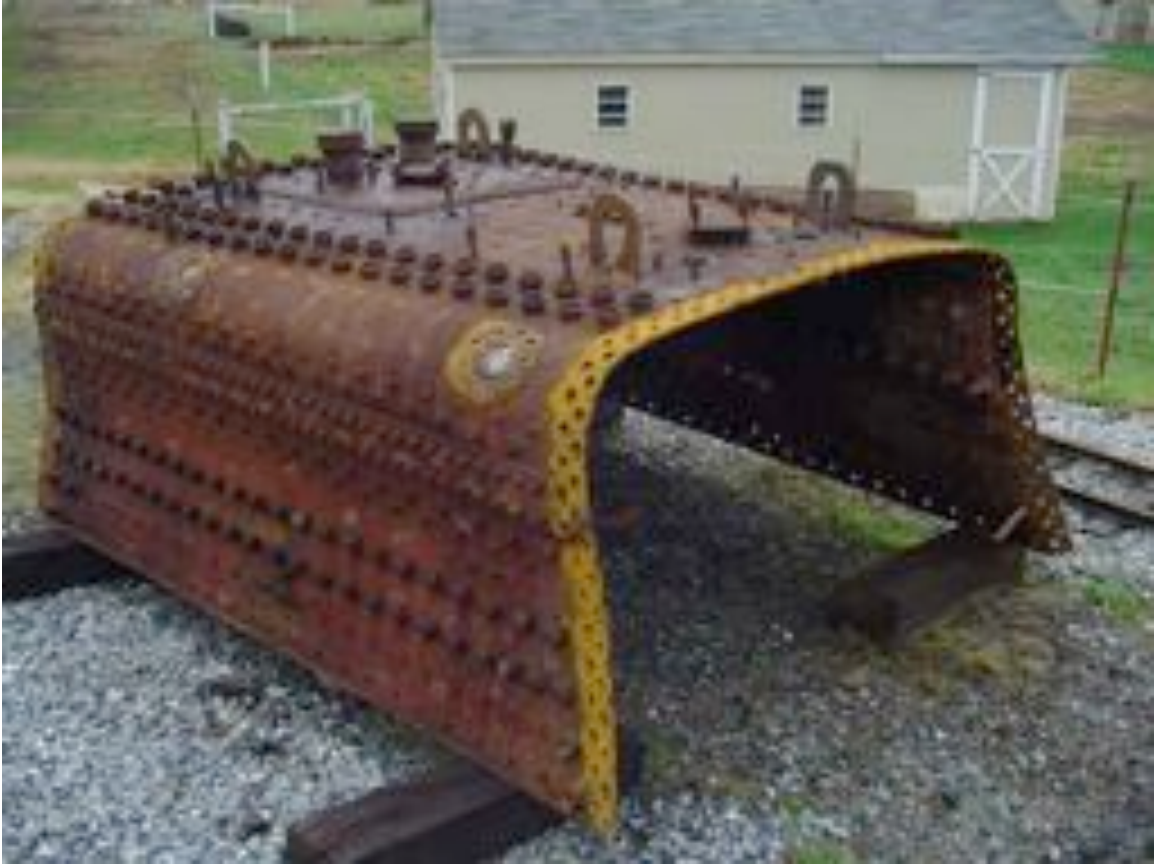
The old upper side sheets and roof sheet, removed from the firebox, rests outside at the Strasburg Railroad Company Erecting Shop.

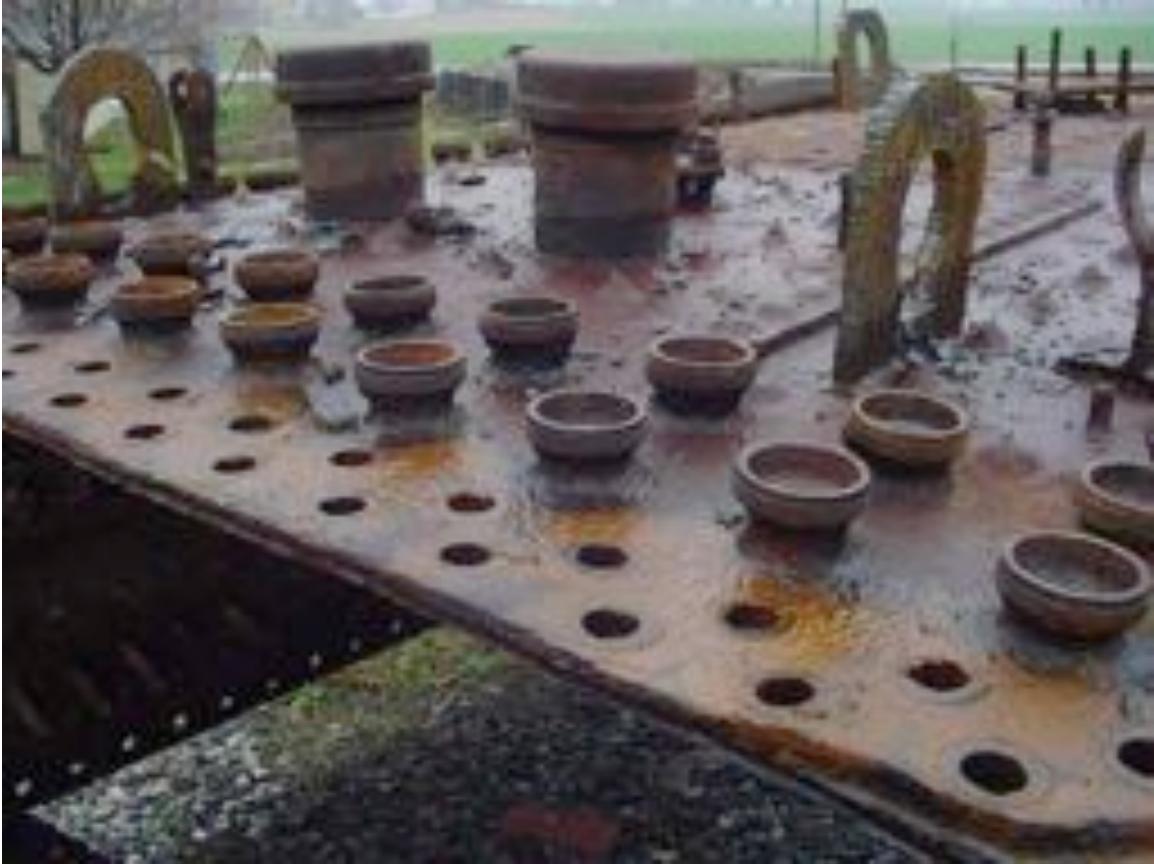
Here we see the troublesome area of #39's roof sheet. (Also a problem area affecting the restoration of Pennsy K4 #1361.) As discussed in August, the pitch of the staybolts supporting the 3/8" thick roof sheet lowered the locomotive's acceptable operating pressure below the normal 208 lbs. To correct this issue, new 1/2" thick sheet steel will be used to replace 39's roof sheet - increasing the structural strength to support an acceptable operating pressure.
