Report from Strasburg Observations

On Friday, November 14, 2008 I met with Rick Musser at the Strasburg Railroad Company to inspect work progressing on the firebox of Engine 39. I am pleased to report that much has occurred on the firebox since my visit three months ago on August 19.

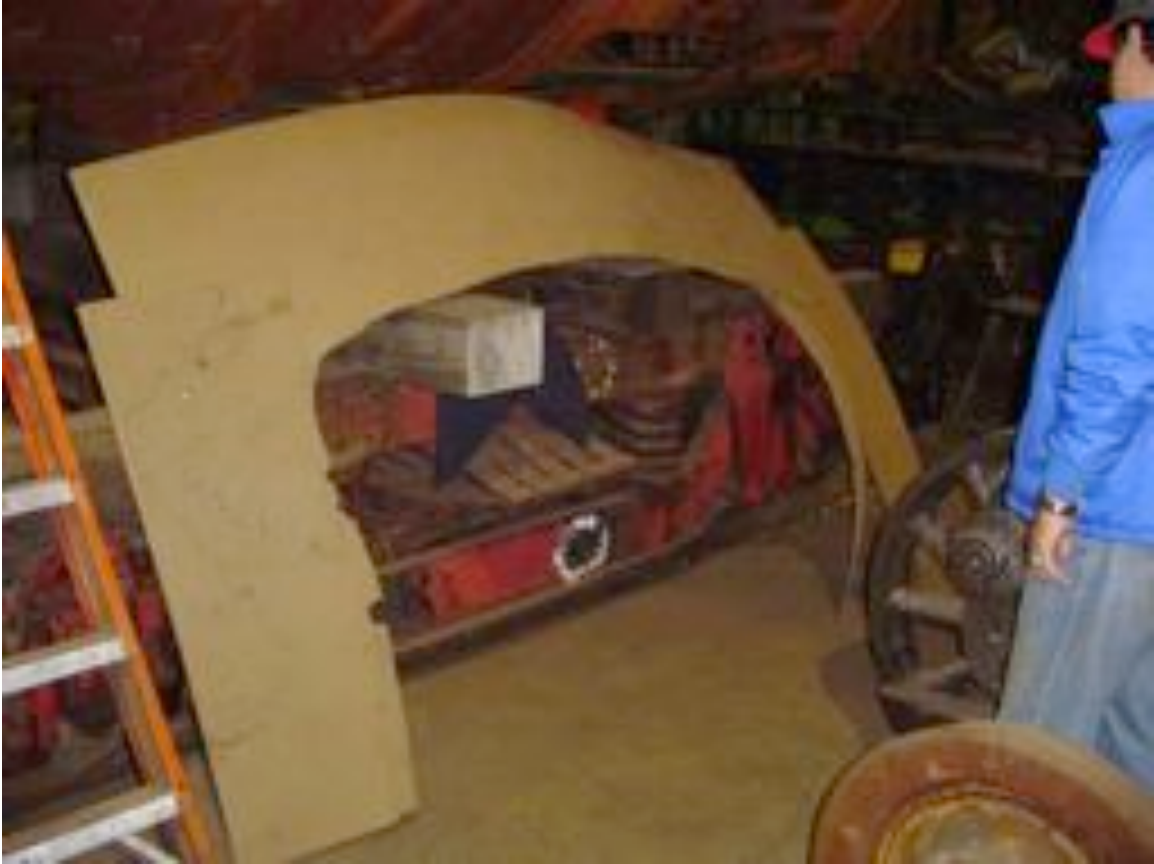
Before the roof and side sheets were removed, Masonite templates were made to assist in the formation of the new side sheet material and roof sheet.

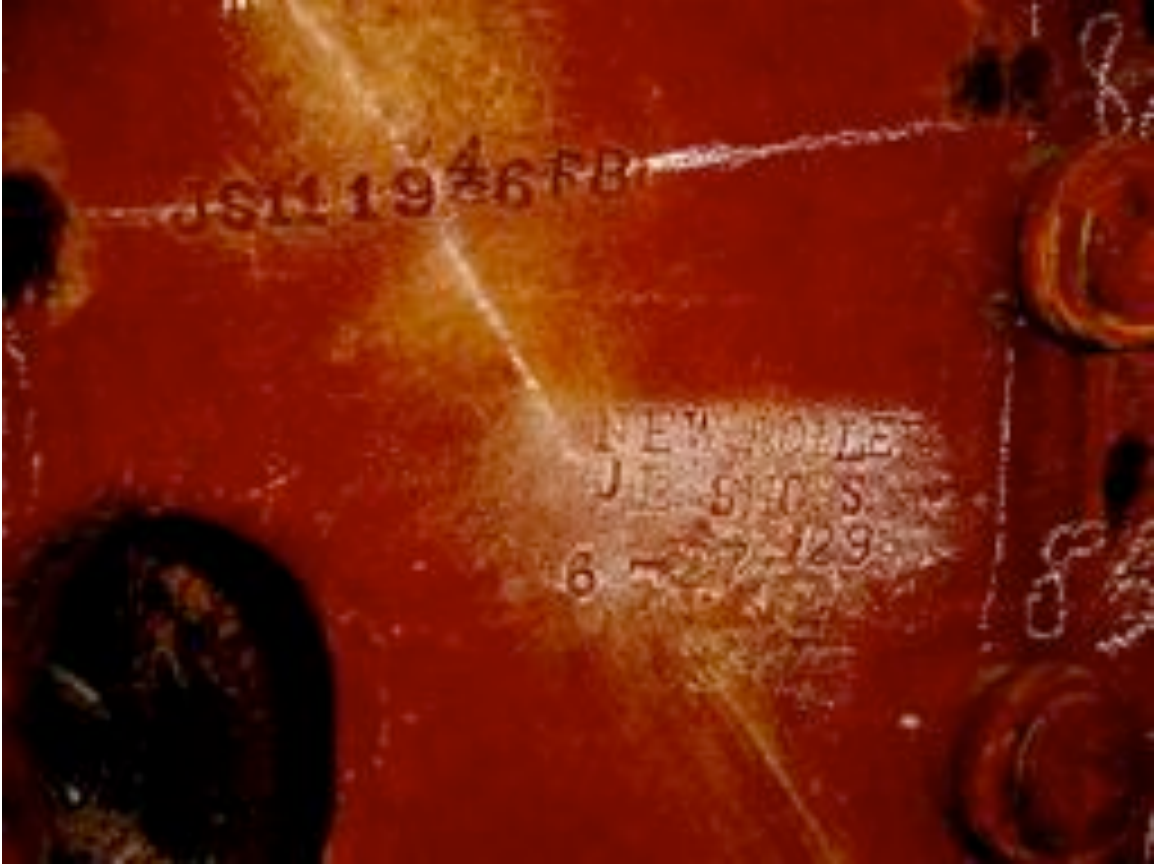
A final photo of interest. In the lower right hand corner of the firebox is a stamping placed there by Pennsylvania Railroad Craftsmen at the time the boiler was built. It reads: NEW BOILER JL SHOPS 6-27-29.
